Technical Service Bulletin

01 MIL on (DTC P0300, P130A, and/or P0301 through P0304)

01 13 08 2033561/2 June 21, 2013. Supersedes Technical Service Bulletin Group 01 number 13-95 dated May 13, 2013 for reasons listed below.

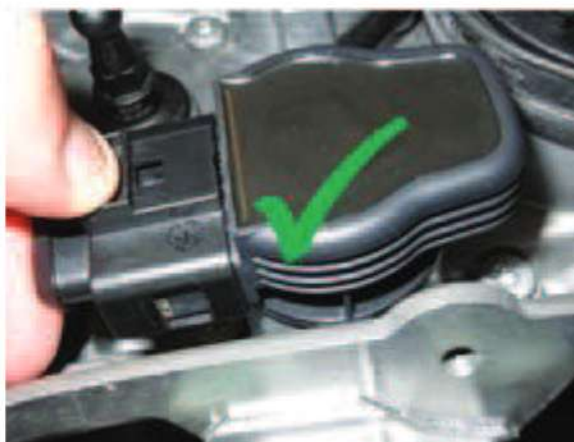
Figure 1. Correct method of disconnecting the ignition coil.

1. Confirm that misfire faults are stored in the ECM memory.
2. Disconnect the connectors from the ignition coils by first pushing the connector towards the ignition coil, then pulling the release tab with thumb, then pulling the connector off the ignition coil (Figure 1).

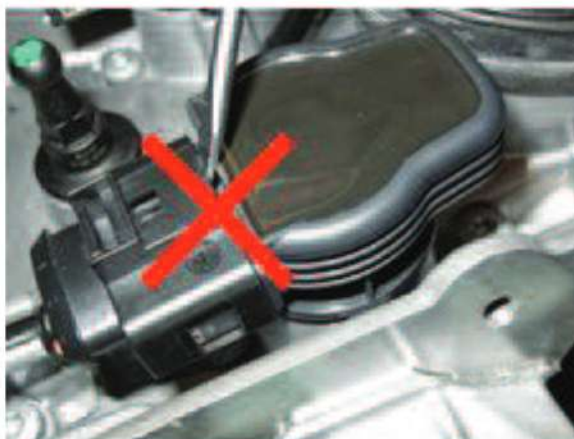
Note: Never use a screw driver, pick or any other tool to unlock and remove the connector, as damage to the connector may occur (Figures 2 and 3).

Figure 2. Incorrect method of disconnecting the ignition coil.

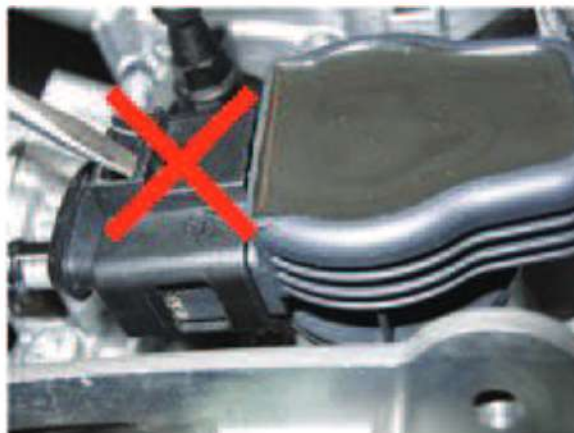
Figure 3. Incorrect method of disconnecting the ignition coil.

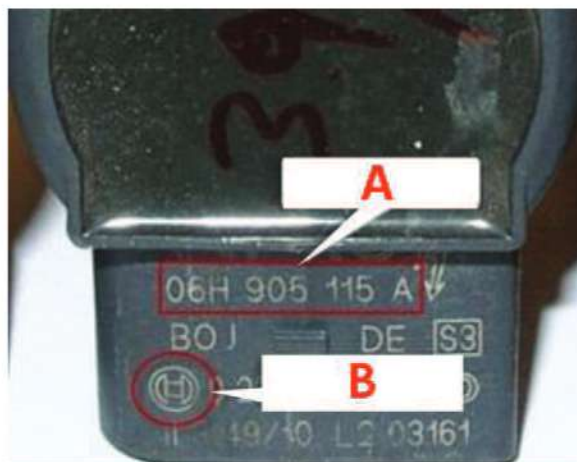
Some of the Bosch ignition coils installed in the affected vehicles may fail prematurely.

3. Check the part number of the coils (Figure 3). If one of the following part numbers is installed, all four ignition coils will need to be replaced:

- 06H 905 115
- 06H 905 115 A
- 06H 905 115 B

Figure 3. A) part number, B) Bosch symbol.

4. Replace all four ignition coils with part number **07K905715F** (ELDOR).

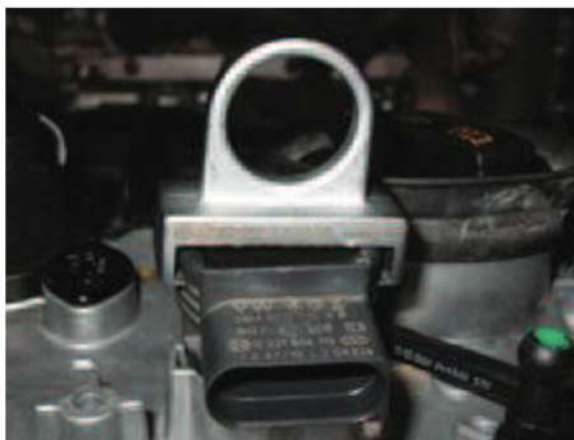
Figure 4. Special tool T40039.

Note: Always use special tool **T40039** to remove ignition coils (Figure 4).
