Technical Bulletin #597

- Transmission: 722.3 & 4
- Subject: 2-3 flare
- Application: Mercedes

February 2001

2-3 Flare

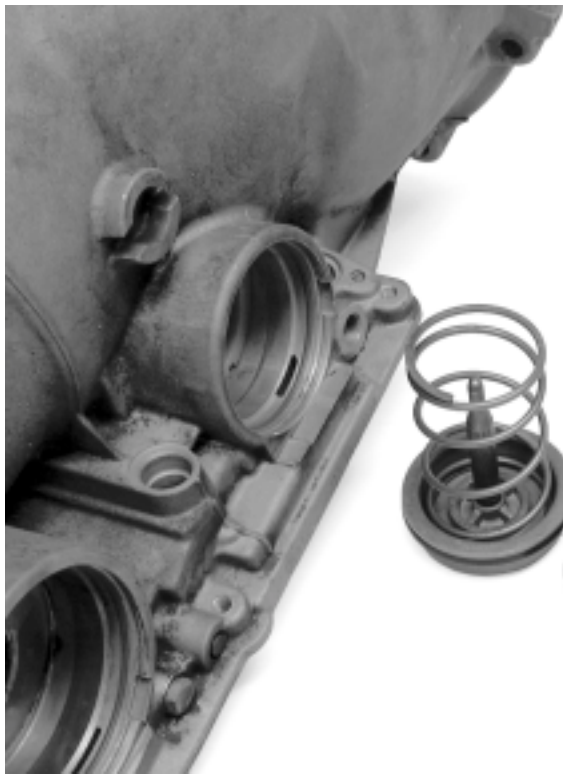
During the 2-3 shift, the B1 band releases while the K1 clutch engages. If working (mainline) and modulator pressures are normal, and the band adjustment is correct (0.2 mm) you can fix a 2-3 flare by removing one of the B1 release springs. Both springs are similar in tension, so it doesn't matter which one you remove.

An effective measure against 2-3 flare problems is to use the self-adjusting servo. The part number for the self-adjusting B1 servo is 124 270 12 32.

If you upgrade to the self-adjusting servo you must also use the later-model servo guide. The part number for the later-style guide is 140 277 08 40.
