Fig. 2: Identifying Instrument Cluster Connector Terminals
Courtesy of CHRYSLER CORP.

1993 Plymouth Grand Voyager

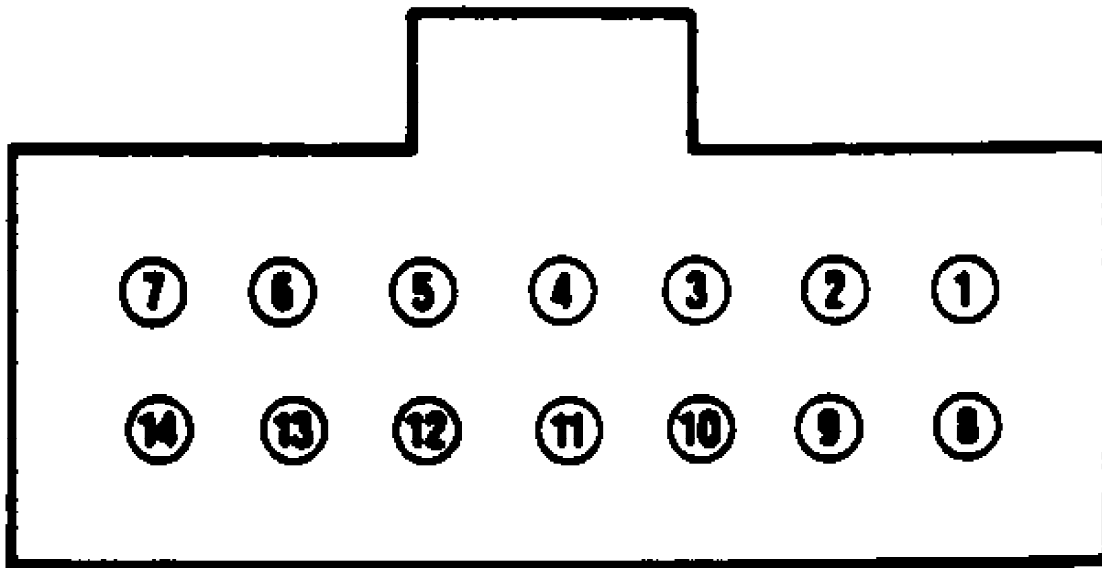
VIEW FROM WIRE END

| 1. Not Used | 8. Low Oil Pressure Switch |
| 2. Battery (B+) | 9. BUS (-) |
| 3. Decode 1 | 10. BUS (+) |
| 4. Not Used | 11. Ignition Feed |
| 5. Decode 2 | 12. Not Used |
| 6. Illumination Feed | 13. Not Used |
| 7. Ground (B-) | 14. Illumination Ground |
